**Flood Control Project Maintenance
Levee Inspections**

Maintenance Issue Types Only, Levee Inspection Report By Mile - Spring 2018

Tehama County Flood Control and Water Conservation District

Waterway	Bank	Unit Miles	Inspection Start/End	Inspector
Unit No. 01 Deer Creek	Left	4.22	04/04/2018 04/04/2018	Bob Duffey

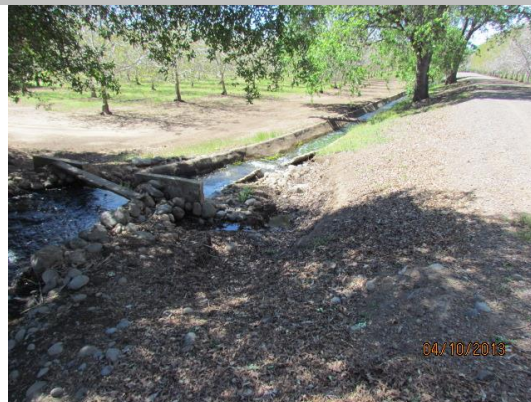
Photo 1 of 1 : SP_2018_NA0019_78_17_20180305_00005.jpg

LM Start	0.01	Rating **	M	Issue No.	17
LM End	0.01	Issue Type +	Ma	Location *	LS
Category	Earthen Levee			GPS Latitude/Longitude	
				Start	End
Item	Erosion / Bank Caving			39.973111 °	39.973111 °
				-121.980466 °	-121.980466 °
DWR ID	DWR_NA0019_01_s _ 2013_17				
Comment Code					
E1 : Note and monitor erosion site.					
Inspector Comment

View of the erosion along the landside slope.

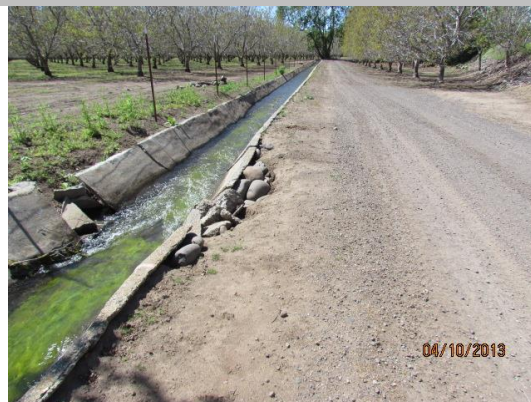
Photo 1 of 1 : SP_2018_NA0019_78_18_20180305_00006.jpg

LM Start	0.41	Rating **	M	Issue No.	18
LM End	0.41	Issue Type +	Ma	Location *	LS
Category	Earthen Levee			GPS Latitude/Longitude	
				Start	End
Item	Erosion / Bank Caving			39.972560 °	39.972560 °
				-121.987759 °	-121.987759 °
DWR ID	DWR_NA0019_01_s _ 2013_18				
Comment Code					
E1 : Note and monitor erosion site.					
Inspector Comment

View of the erosion along the landside slope.

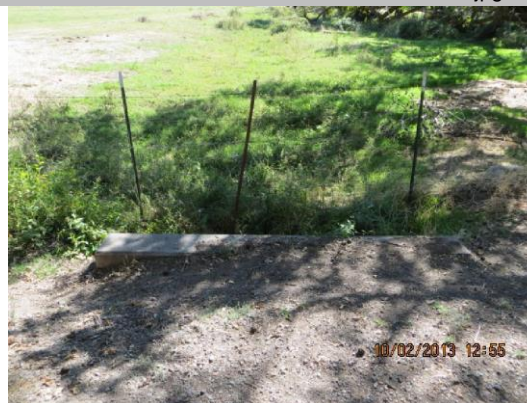
Photo 2 of 3 : UCIP_SP_2018_51437_36921.jpg

FS_ID:51437
DS_ID:20770
EP_NO: N/A
Repair Type: Non-Urgent
Crossing Status: Found
UCIP Comments: 12/05/2016 Sediment buildup inside pipe (see photo) and sediment buildup on WS blocking flap gate. Crossing has been downgraded from Urgent to Non-Urgent crossing was closed on both WS and LS. (O. Magana - DWR UCIP) 10/02/2013 Flapgate blocked by soil buildup. (W. Wylie - DWR UCIP)
FIELD_STRUCT_DESC: 24-inch steel drainage pipe through the levee, 1.5 feet below the crown. Flap gate on the waterside (WS) toe.
[Additional Reference(s): DWR Levee Log, 1992. USACE Sacramento O&M Manual Unit 509, March 1957, As-built drawings available 50-4-2394 (Station 185+40)].
FS Date: 12/5/2016

Concrete headwall on LS toe.

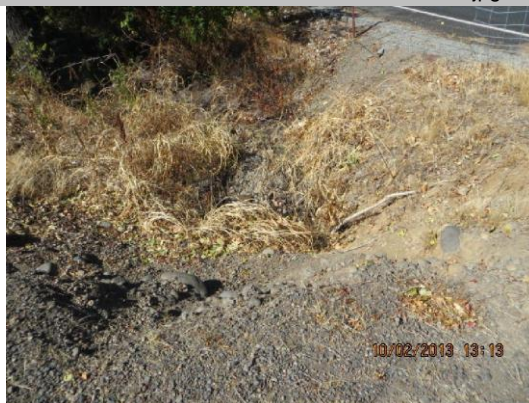
Photo 2 of 3 : UCIP_SP_2018_51438_36924.jpg

FS_ID:51438
DS_ID:20769
EP_NO: N/A
Repair Type: Urgent
Crossing Status: Found
UCIP Comments: 12/05/2016 same as last inspection. Crossing remains "Urgent" WS opened during flood season due to damaged flap gate. (O. Magana - DWR UCIP)10/02/2013 Flapgate missing or buried on WS toe. Pipe partially blocked by soil on WS toe. (W. Wylie - DWR UCIP)
FIELD_STRUCT_DESC: 24-inch corrugated metal drainage pipe through the levee, 7 feet below the crown. Flap gate located on the waterside (WS) end. A 5-foot by 5-foot concrete control structure located on the landside (LS) toe. [Additional Reference(s): DWR Levee Log, 1992. USACE Sacramento O&M Manual Unit 509, March 1957, As-built drawing no. 50-4-2394 (Station 176+10)].
FS Date: 12/5/2016

Outlet on WS toe.

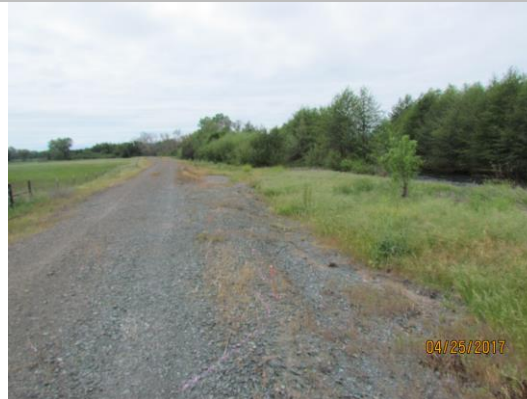
Photo 1 of 1 : SP_2018_NA0019_78_39_20180305_00014.jpg

LM Start	2.53	Rating **	M	Issue No.	39
LM End	2.53	Issue Type +	Ma	Location *	WS
Category	Earthen Levee			GPS Latitude/Longitude	
				Start	End
Item	Erosion / Bank Caving			39.966675 °	39.966675 °
				-122.024988 °	-122.024988 °
DWR ID	DWR_NA0019_01_s_2017_39				
Comment Code					
E2 : Schedule repair of erosion site prior to the next inspection.					
Inspector Comment					
Repair the erosion along the water side slope.

View of erosion along the waterside slope.

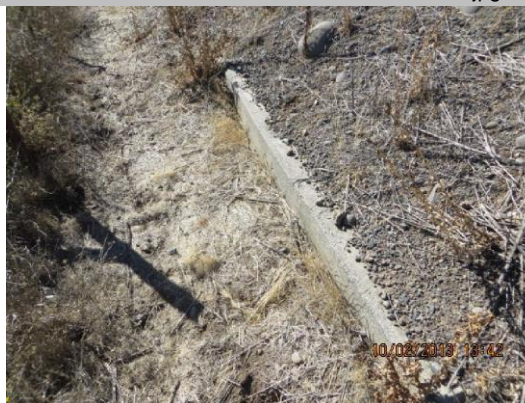
Photo 1 of 1 : UCIP_SP_2018_22823_38941.jpg

LM Start	2.57	Rating **	M	Issue No.	283
LM End	2.57	Issue Type +	Ma	Location *	
Category	Supplemental			GPS Latitude/Longitude	
				Start	End
Item	DWR UCIP LMA Responsibility			39.966363 °	39.966363 °
				-122.025755 °	-122.025755 °
DWR ID					
Comment Code					
Inspector Comment					
FS_ID:22823					
DS_ID:20877					
EP_NO: N/A					
Repair Type: Non-Urgent					
Crossing Status: Found					
UCIP Comments: Headwall covered with soil. Needs to be cleared at both ends.					
FIELD_STRUCT_DESC: 24-inch corrugated metal pipe through the levee 5-feet below the crown. Calco automatic drainage gate.					
Originally included in O+M manual (1957). As-built drawings available 50-4-2394.					
FS Date: 10/2/2013

Concrete headwall on LS toe.

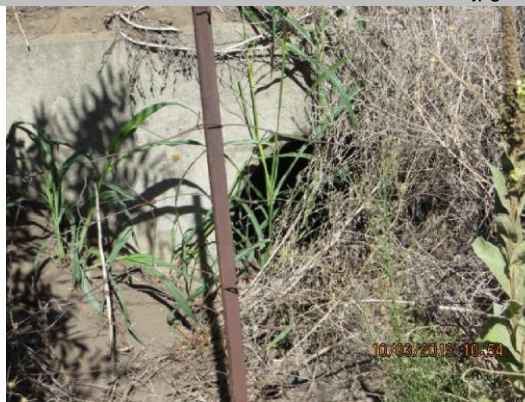
Photo 1 of 3 : UCIP_SP_2018_21741_36937.jpg

LM Start	4.03	Rating **	A/W	Issue No.	291
LM End	4.03	Issue Type +	Ma	Location *	
Category	Supplemental			GPS Latitude/Longitude	
				Start	End
Item	DWR UCIP LMA Responsibility			39.941574 °	39.941574 °
				-122.057597 °	-122.057597 °
DWR ID					
Comment Code					
Inspector Comment					
FS_ID:21741					
DS_ID:20760					
EP_NO: N/A					
Repair Type: No Action Needed					
Crossing Status: Found					
UCIP Comments:					
FIELD_STRUCT_DESC: 24-inch corrugated metal drainage pipe through the levee, 5 feet below the crown. Flap gate on the waterside (WS) end. Headwalls on both sides of levee. [Additional Reference(s): DWR Levee Log, 1992. USACE Sacramento O&M Manual 509, March 1957, (Assumed Station 5+00) Drawing No. 50-4-2394].					
FS Date: 10/3/2013

Pipe and concrete headwall on LS toe.

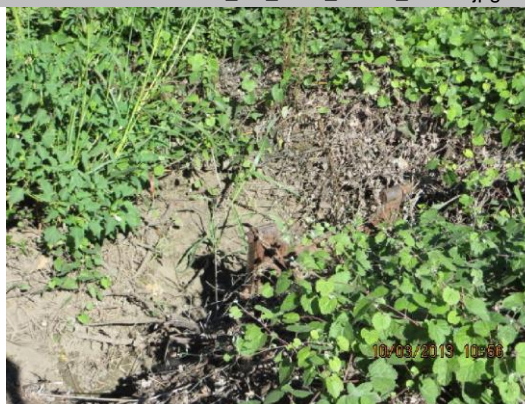
Photo 2 of 3 : UCIP_SP_2018_21741_36936.jpg

Flapgate on WS toe.

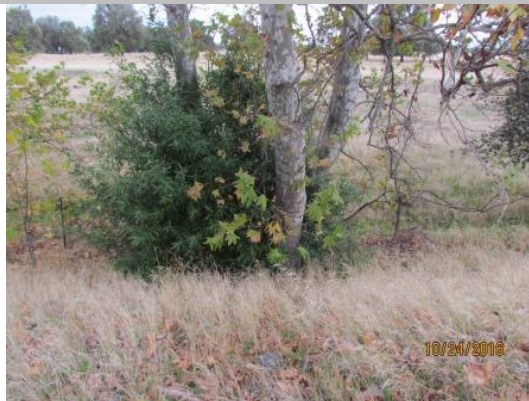
Photo 1 of 1 : SP_2018_NA0019_79_13_20180305_00008.jpg

LM Start	0.23	Rating **	M	Issue No.	13
LM End	0.23	Issue Type +	Ma	Location *	LS
Category	Earthen Levee			GPS Latitude/Longitude	
				Start	End
Item	Trim / Thin Trees			39.970598 °	39.970598 °
				-122.013053 °	-122.013053 °
DWR ID	DWR_NA0019_02_f_2016_13				
Comment Code					
T1 : Trim trees to at least five feet above ground level.					
Inspector Comment					
Remove trees smaller than 4-inches in diameter at chest height.

View of a tree with new thick growth blocking visibility.

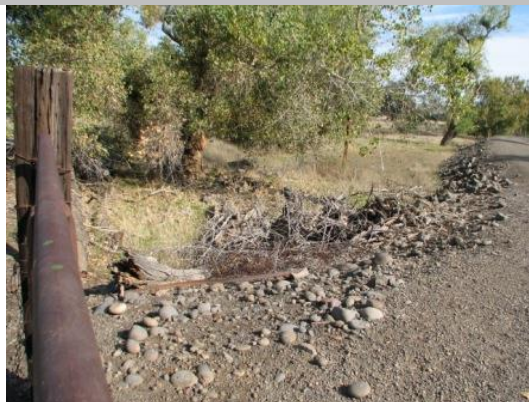
Photo 1 of 1 : SP_2018_NA0019_79_2_20180305_00001.jpg

LM Start	0.30	Rating **	M	Issue No.	2
LM End	0.30	Issue Type +	Ma	Location *	LS
Category	Earthen Levee			GPS Latitude/Longitude	
				Start	End
Item	Encroachments			39.970305 °	39.970305 °
				-122.014465 °	-122.014465 °
DWR ID	DWR_NA0019_02_s_2012_2				
Comment Code					
DE : Debris					
Inspector Comment

View of debris and wire at the toe of levee.

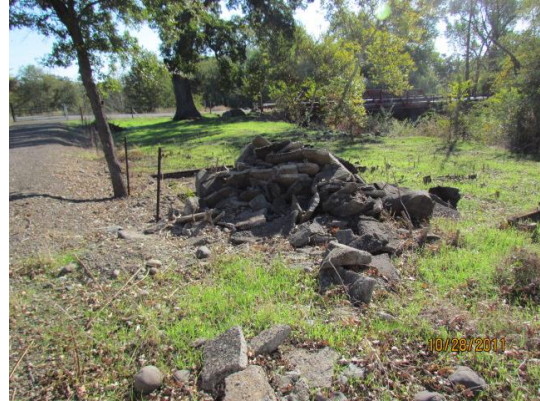
Photo 1 of 1 : SP_2018_NA0019_79_4_20180305_00003.jpg

LM Start	0.34	Rating **	M	Issue No.	4
LM End	0.34	Issue Type +	Ma	Location *	WS
Category	Earthen Levee			GPS Latitude/Longitude	
				Start	End
Item	Encroachments			39.970210 °	39.970210 °
				-122.015198 °	-122.015198 °
DWR ID	DWR_NA0019_02_s_2012_4				
Comment Code					
DE : Debris					
Inspector Comment

View of the concrete pile along the waterside toe.

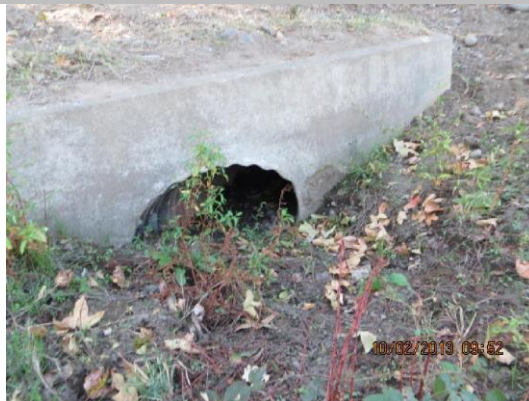
Photo 2 of 3 : UCIP_SP_2018_51442_36901.jpg

Concrete headwall at LS toe.

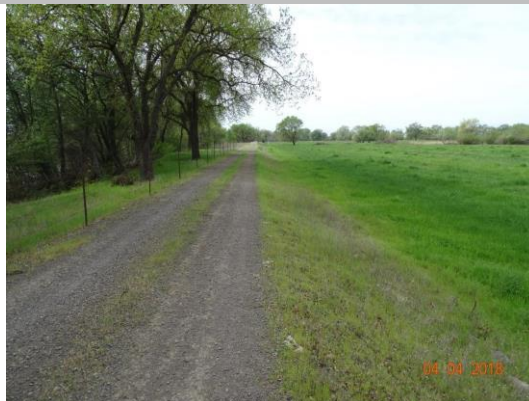
Photo 1 of 1 : SP_2018_NA0019_79_20_20180405_00019.jpg

LM Start	0.87	Rating **	A	Issue No.	20
LM End	0.87	Issue Type +	Ma	Location *	LS
Category	Earthen Levee			GPS Latitude/Longitude	
				Start	End
Item	Vegetation			39.968133 °	39.968133 °
				-122.024170 °	-122.024170 °
DWR ID	DWR_NA0019_02_s _ 2018_20				
Comment Code					
V1 : Control annual grass and weeds on the levee slopes and easements.					
Inspector Comment					
Native vegetation is well maintained on both slopes.

View of native vegetation on both slopes.

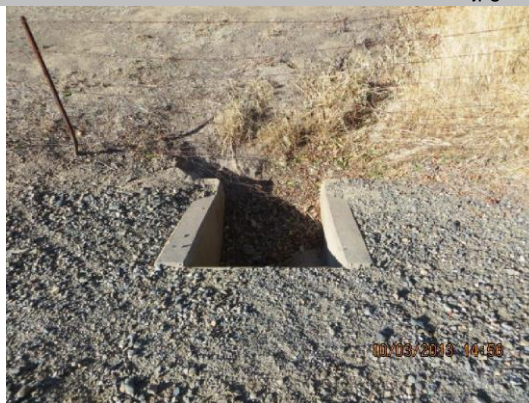
Photo 1 of 3 : UCIP_SP_2018_21795_37074.jpg

LM Start	0.25	Rating **	A/W	Issue No.	917	
LM End	0.25	Issue Type +	Ma	Location *		
Category	Supplemental			GPS Latitude/Longitude		
				Start		End
Item	DWR UCIP LMA Responsibility			40.051604 °		40.051604 °
				-122.184431 °		-122.184431 °
DWR ID						
Comment Code						
Inspector Comment						
FS_ID:21795 DS_ID:20775 EP_NO: N/A Repair Type: No Action Needed Crossing Status: Found UCIP Comments: FIELD_STRUCT_DESC: 24-inch corrugated metal drainage pipe through the levee, 4 feet below the crown. Flap gate and concrete U-shaped headwall on the waterside (WS) end. Concrete U-shaped headwall on the landside (LS) end. [Additional Reference(s): DWR Levee Log, 1992. USACE Sacramento O&M Manual 510, April 1963, (HLM 0.26) Drawing No. 50-4-3622]. FS Date: 10/3/2013

Concrete U-shaped headwall on LS toe.

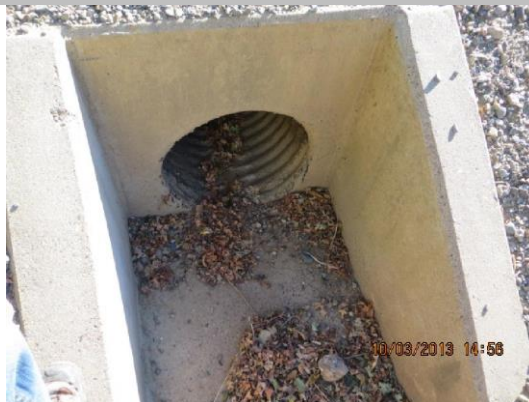
Photo 2 of 3 : UCIP_SP_2018_21795_37073.jpg

Concrete U-shaped headwall on LS toe.

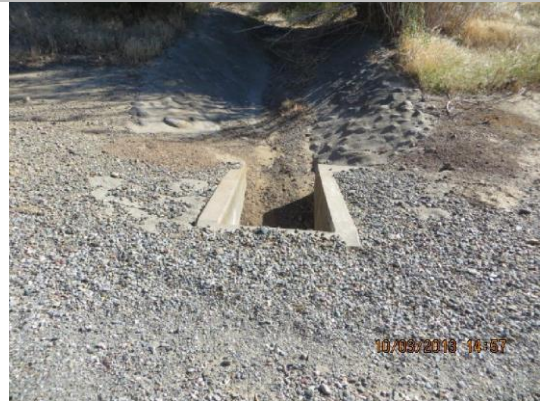
Photo 3 of 3 : UCIP_SP_2018_21795_37072.jpg

Concrete U-shaped headwall on WS toe.

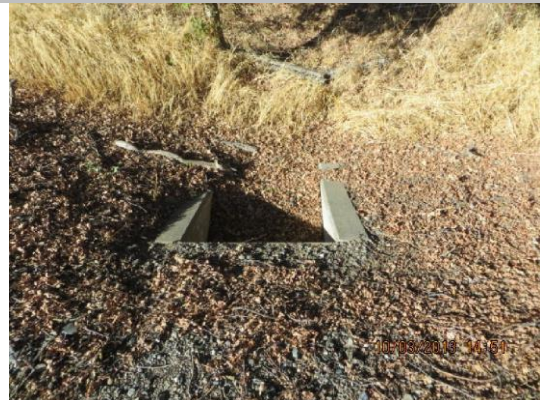
Photo 1 of 3 : UCIP_SP_2018_22826_38961.jpg

LM Start	0.38	Rating **	A/W	Issue No.	918
LM End	0.38	Issue Type +	Ma	Location *	
Category	Supplemental			GPS Latitude/Longitude	
				Start	End
Item	DWR UCIP LMA Responsibility			40.051572 °	40.051572 °
				-122.182093 °	-122.182093 °
DWR ID					
Comment Code					
Inspector Comment					
FS_ID:22826 DS_ID:20776 EP_NO: N/A Repair Type: No Action Needed Crossing Status: Found UCIP Comments: FIELD_STRUCT_DESC: 24-inch corrugated metal drainage pipe through the levee, 4.5 feet below the crown. Flap gate and concrete U-shaped headwall on the waterside (WS) end. Concrete U-shaped headwall on the landside (LS) end. [Additional Reference(s): DWR Levee Log, 1992. USACE Sacramento O&M Manual 510, April 1963, (HLM 0.39) Drawing No. 50-4-3622]. FS Date: 10/3/2013

Concrete U-shaped headwall on LS toe.

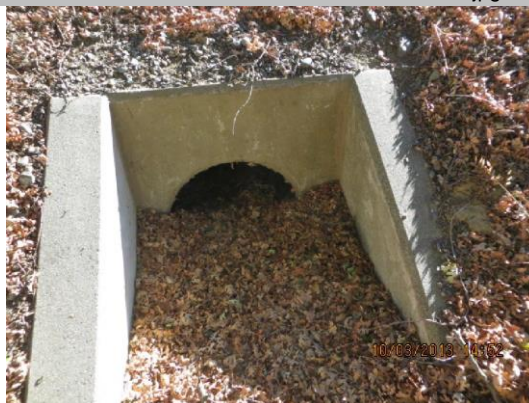
Photo 2 of 3 : UCIP_SP_2018_22826_38960.jpg

Concrete U-shaped headwall on LS toe.

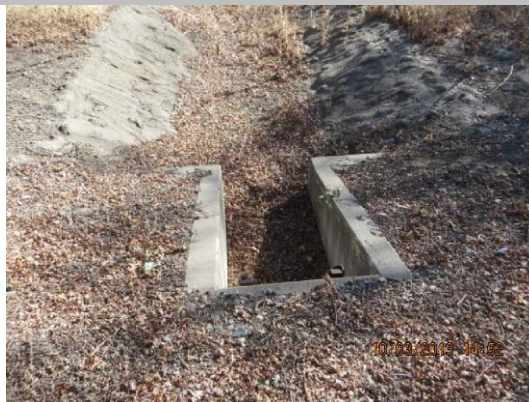
Photo 3 of 3 : UCIP_SP_2018_22826_38963.jpg

Concrete U-shaped headwall with concrete swale on WS toe.

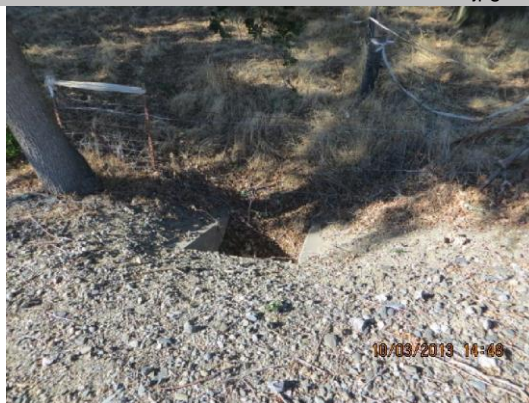
Photo 1 of 3 : UCIP_SP_2018_21793_37069.jpg

LM Start	0.51	Rating **	A/W	Issue No.	919	
LM End	0.51	Issue Type +	Ma	Location *		
Category	Supplemental			GPS Latitude/Longitude		
				Start		End
Item	DWR UCIP LMA Responsibility			40.051211 °	40.051211 °	
				-122.179663 °	-122.179663 °	
DWR ID						
Comment Code						
Inspector Comment						
FS_ID:21793 DS_ID:20777 EP_NO: N/A Repair Type: No Action Needed Crossing Status: Found UCIP Comments: FIELD_STRUCT_DESC: 24-inch corrugated metal drainage pipe through the levee, 5 feet below the crown. Flap gate and concrete U-shaped headwall on the waterside (WS) end. Concrete U-shaped headwall on the landside (LS) end. [Additional Reference(s): DWR Levee Log, 1992. USACE Sacramento O&M Manual 510, April 1963, (HLM 0.52) Drawing No. 50-4-3622]. FS Date: 10/3/2013

Concrete U-shaped headwall on LS toe.

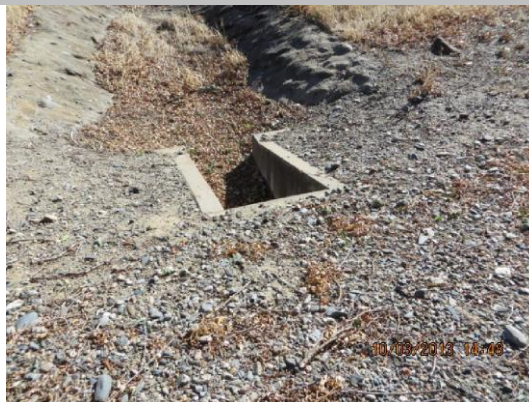
Photo 2 of 3 : UCIP_SP_2018_21793_37068.jpg

Concrete U-shaped headwall on WS toe.

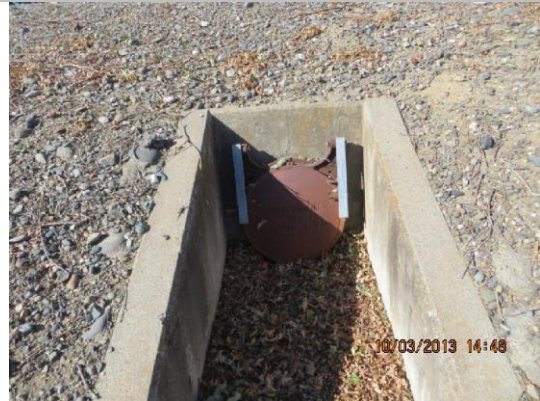
Photo 3 of 3 : UCIP_SP_2018_21793_37067.jpg

Concrete U-shaped headwall and flapgate on WS toe.

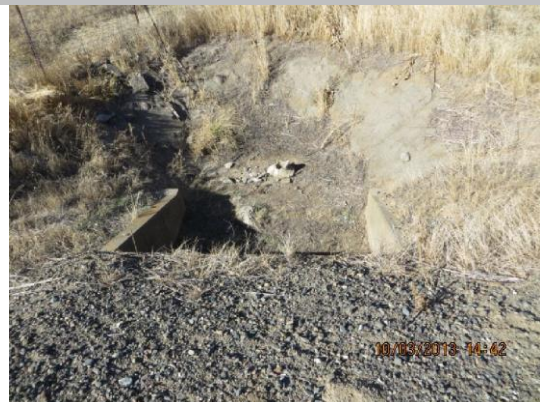
Photo 1 of 3 : UCIP_SP_2018_21792_37065.jpg

LM Start	0.64	Rating **	A/W	Issue No.	920
LM End	0.64	Issue Type +	Ma	Location *	
Category	Supplemental			GPS Latitude/Longitude	
				Start	End
Item	DWR UCIP LMA Responsibility			40.051699 °	40.051699 °
				-122.177320 °	-122.177320 °
DWR ID					
Comment Code					
Inspector Comment					
FS_ID:21792 DS_ID:20778 EP_NO: N/A Repair Type: No Action Needed Crossing Status: Found UCIP Comments: FIELD_STRUCT_DESC: 1 of 2: 36-inch corrugated metal drainage pipe through the levee, 8.6 feet below the crown. Flap gate and concrete U-shaped headwall on the waterside (WS) end. Concrete U-shaped headwall on the landside (LS) end. [Additional Reference(s): DWR Levee Log, 1992. USACE Sacramento O&M Manual 510, April 1963, (HLM 0.65) Drawing No. 50-4-3622]. FS Date: 10/3/2013

Concrete U-shaped headwall on LS toe.

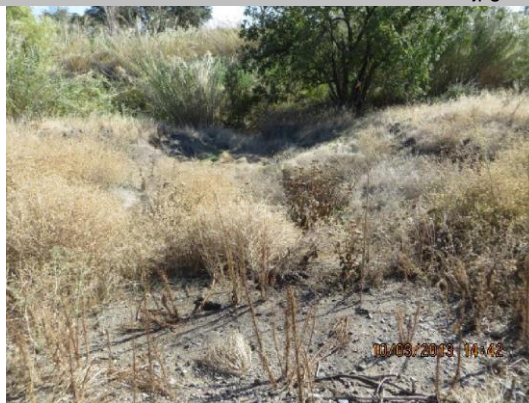
Photo 2 of 3 : UCIP_SP_2018_21792_37064.jpg

Concrete U-shaped headwall on WS toe.

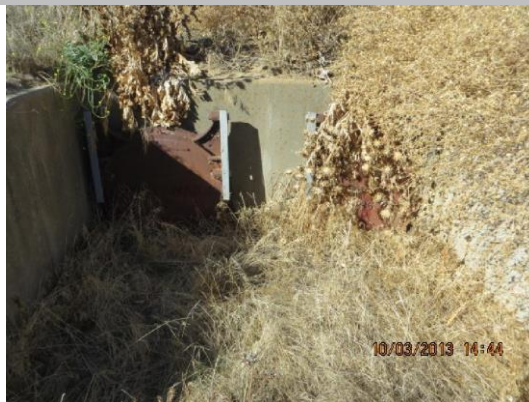
Photo 3 of 3 : UCIP_SP_2018_21792_37063.jpg

Concrete U-shaped headwall and flapgate on WS toe.

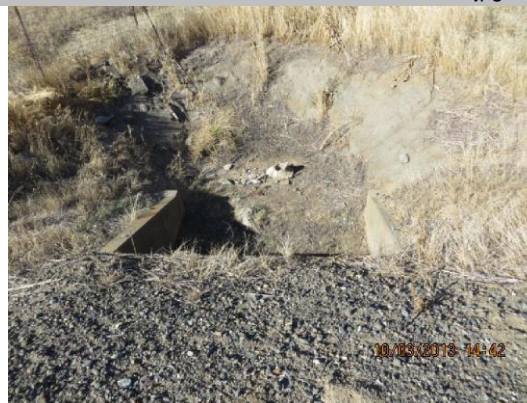
Photo 1 of 3 : UCIP_SP_2018_51443_37061.jpg

Concrete U-shaped headwall on LS toe.

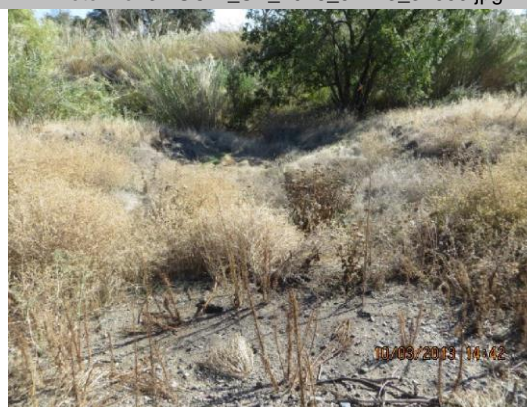
Photo 2 of 3 : UCIP_SP_2018_51443_37060.jpg

FS_ID:51443
DS_ID:20880
EP_NO: N/A
Repair Type: Non-Urgent
Crossing Status: Found
UCIP Comments: 12/05/2016 Crossing has been downgraded from Urgent to Non-Urgent vegetation found on WS but does not appear to prevent proper function of flap gate. Recommend clearing dry vegetation on WS above concrete headwall.(O. Magana - DWR UCIP)10/03/2013 Flapgate operation hindered by soil and vegetation on WS toe. (W. Wylie - DWR UCIP)
FIELD_STRUCT_DESC: 2 of 2: 36-inch corrugated metal drainage pipe through levee, 8.6 feet below crown. Flap gate and concrete "U" headwall located on the waterside (WS) end. Concrete "U" headwall located on the landside (LS) end. [Additional Reference(s): DWR Levee Log, 1992. USACE Sacramento O&M Manual, Unit 510, April 1963, As-built drawing No. 50-4-3622 (HLM 0.65)]
FS Date: 12/5/2016

Concrete U-shaped headwall on WS toe.

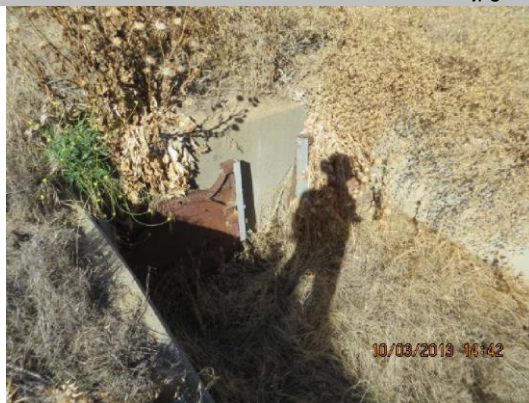
Photo 3 of 3 : UCIP_SP_2018_51443_37059.jpg

Comment Code						
Inspector Comment						
FS_ID:51443 DS_ID:20880 EP_NO: N/A Repair Type: Non-Urgent Crossing Status: Found UCIP Comments: 12/05/2016 Crossing has been downgraded from Urgent to Non-Urgent vegetation found on WS but does not appear to prevent proper function of flap gate. Recommend clearing dry vegetation on WS above concrete headwall.(O. Magana - DWR UCIP)10/03/2013 Flapgate operation hindered by soil and vegetation on WS toe. (W. Wylie - DWR UCIP) FIELD_STRUCT_DESC: 2 of 2: 36-inch corrugated metal drainage pipe through levee, 8.6 feet below crown. Flap gate and concrete "U" headwall located on the waterside (WS) end. Concrete "U" headwall located on the landside (LS) end. [Additional Reference(s): DWR Levee Log, 1992. USACE Sacramento O&M Manual, Unit 510, April 1963, As-built drawing No. 50-4-3622 (HLM 0.65)] FS Date: 12/5/2016

Concrete U-shaped headwall and flapgate on WS toe.

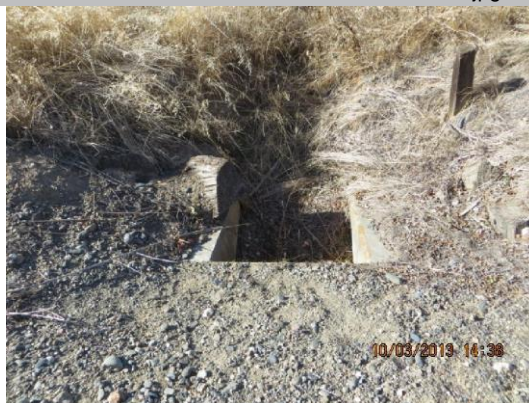
Photo 1 of 3 : UCIP_SP_2018_21790_37057.jpg

LM Start	0.75	Rating **	A/W	Issue No.	922	
LM End	0.75	Issue Type +	Ma	Location *		
Category	Supplemental			GPS Latitude/Longitude		
				Start		End
Item	DWR UCIP LMA Responsibility			40.052194 °		40.052194 °
				-122.175390 °		-122.175390 °
DWR ID						
Comment Code						
Inspector Comment						
FS_ID:21790 DS_ID:20779 EP_NO: N/A Repair Type: No Action Needed Crossing Status: Found UCIP Comments: FIELD_STRUCT_DESC: 24-inch corrugated metal drainage pipe through the levee, 5.8 feet below the crown. Flap gate and concrete U-shaped headwall on the waterside (WS) end. Concrete U-shaped headwall on the landside (LS) end. [Additional Reference(s): DWR Levee Log, 1992. USACE Sacramento O&M Manual 510, April 1963, (HLM 0.76) Drawing No. 50-4-3622]. FS Date: 10/3/2013

Concrete U-shaped headwall on LS toe.

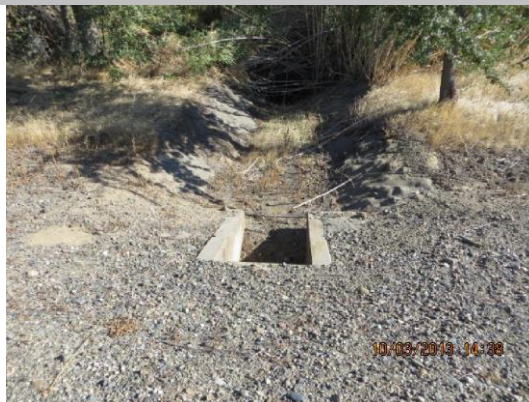
Photo 2 of 3 : UCIP_SP_2018_21790_37056.jpg

Concrete U-shaped headwall on WS toe.

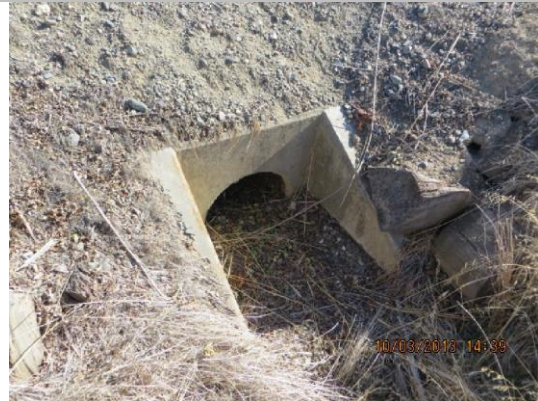
Photo 3 of 3 : UCIP_SP_2018_21790_37055.jpg

LM Start	0.75	Rating **	A/W	Issue No.	922 (cont)
LM End	0.75	Issue Type +	Ma	Location *	
Category	Supplemental			GPS Latitude/Longitude	
				Start	End
Item	DWR UCIP LMA Responsibility			40.052194 °	40.052194 °
				-122.175390 °	-122.175390 °
DWR ID					
Comment Code					
Inspector Comment					
FS_ID:21790 DS_ID:20779 EP_NO: N/A Repair Type: No Action Needed Crossing Status: Found UCIP Comments: FIELD_STRUCT_DESC: 24-inch corrugated metal drainage pipe through the levee, 5.8 feet below the crown. Flap gate and concrete U-shaped headwall on the waterside (WS) end. Concrete U-shaped headwall on the landside (LS) end. [Additional Reference(s): DWR Levee Log, 1992. USACE Sacramento O&M Manual 510, April 1963, (HLM 0.76) Drawing No. 50-4-3622]. FS Date: 10/3/2013

Concrete U-shaped headwall on LS toe.

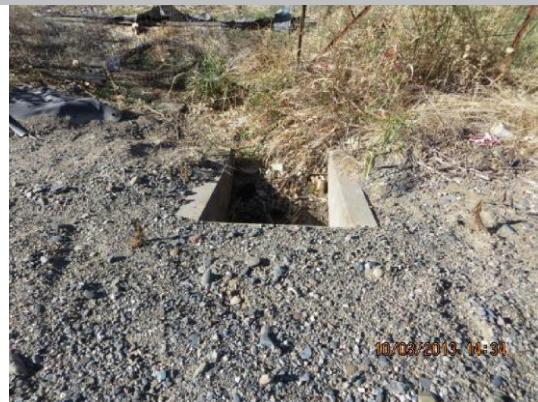
Photo 1 of 3 : UCIP_SP_2018_22827_38970.jpg

LM Start	0.91	Rating **	A/W	Issue No.	923
LM End	0.91	Issue Type +	Ma	Location *	
Category	Supplemental			GPS Latitude/Longitude	
				Start	End
Item	DWR UCIP LMA Responsibility			40.053401 °	40.053401 °
				-122.172848 °	-122.172848 °
DWR ID					
Comment Code					
Inspector Comment					
FS_ID:22827 DS_ID:20780 EP_NO: N/A Repair Type: No Action Needed Crossing Status: Found UCIP Comments: FIELD_STRUCT_DESC: 24-inch corrugated metal drainage pipe through the levee, 4.5 feet below the crown. Flap gate and concrete U-shaped headwall on the waterside (WS) end. Concrete U-shaped headwall on the landside (LS) end. [Additional Reference(s): DWR Levee Log, 1992. USACE Sacramento O&M Manual 510, April 1963, (HLM 0.93) Drawing No. 50-4-3622]. FS Date: 10/3/2013

Concrete U-shaped headwall on LS toe.

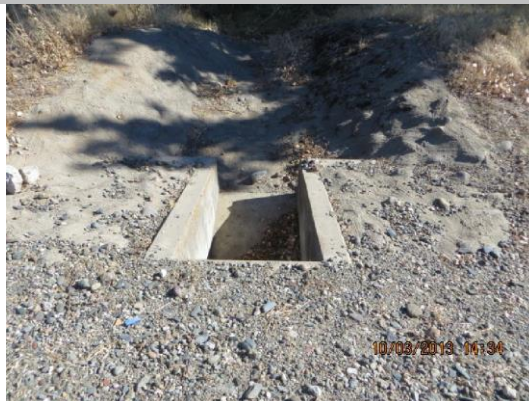
Photo 2 of 3 : UCIP_SP_2018_22827_38969.jpg

FS_ID:22827
DS_ID:20780
EP_NO: N/A
Repair Type: No Action Needed
Crossing Status: Found
UCIP Comments:
FIELD_STRUCT_DESC: 24-inch corrugated metal drainage pipe through the levee, 4.5 feet below the crown. Flap gate and concrete U-shaped headwall on the waterside (WS) end. Concrete U-shaped headwall on the landside (LS) end. [Additional Reference(s): DWR Levee Log, 1992. USACE Sacramento O&M Manual 510, April 1963, (HLM 0.93) Drawing No. 50-4-3622].
FS Date: 10/3/2013

Concrete U-shaped headwall on WS toe.

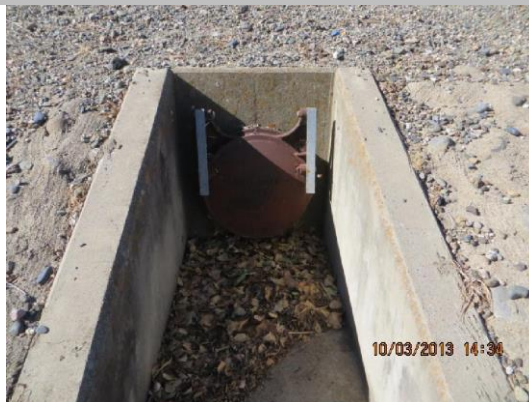
Photo 3 of 3 : UCIP_SP_2018_22827_38972.jpg

Flapgate on headwall at WS toe.

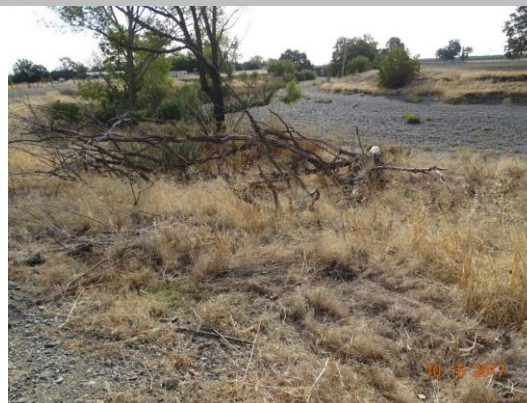
Photo 1 of 1 : SP_2018_NA0019_81_50_20180305_00023.jpg

LM Start	0.92	Rating **	M	Issue No.	50
LM End	0.92	Issue Type +	Ma	Location *	WS
Category	Earthen Levee			GPS Latitude/Longitude	
				Start	End
Item	Encroachments			40.053420 °	40.053420 °
				-122.172617 °	-122.172617 °
DWR ID	DWR_NA0019_04_f_2017_50				
Comment Code					
TR : Tree or limb					
Inspector Comment					
Remove the tree from the waterside toe.

View of the tree along waterside toe.

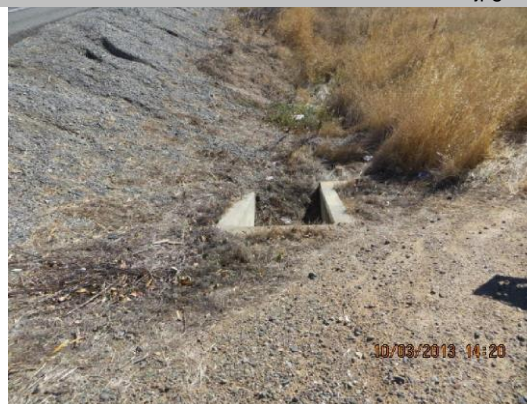
Photo 1 of 3 : UCIP_SP_2018_21788_37050.jpg

LM Start	1.07	Rating **	A/W	Issue No.	924
LM End	1.07	Issue Type +	Ma	Location *	
Category	Supplemental			GPS Latitude/Longitude	
				Start	End
Item	DWR UCIP LMA Responsibility			40.052400 °	40.052400 °
				-122.170279 °	-122.170279 °
DWR ID					
Comment Code					
Inspector Comment					
FS_ID:21788 DS_ID:20790 EP_NO: N/A Repair Type: No Action Needed Crossing Status: Found UCIP Comments: FIELD_STRUCT_DESC: 24-inch corrugated metal drainage pipe through the levee, 5 feet below the crown. Flap gate and concrete U-shaped headwall on the waterside (WS) end. Concrete U-shaped headwall on the landside (LS) end. [Additional Reference(s): DWR Levee Log, 1992. USACE Sacramento O&M Manual 510, April 1963, (HLM 1.10) Drawing No. 50-4-3622]. FS Date: 10/3/2013

Concrete U-shaped headwall on WS toe.

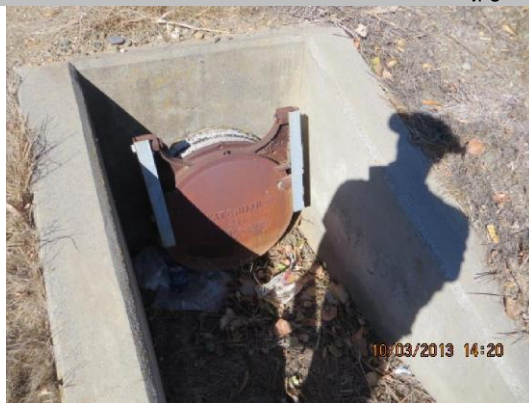
Photo 2 of 3 : UCIP_SP_2018_21788_37053.jpg

LM Start	1.07	Rating **	A/W	Issue No.	924 (cont)
LM End	1.07	Issue Type +	Ma	Location *	
Category	Supplemental			GPS Latitude/Longitude	
				Start	End
Item	DWR UCIP LMA Responsibility			40.052400 °	40.052400 °
				-122.170279 °	-122.170279 °
DWR ID					
Comment Code					
Inspector Comment					
FS_ID:21788 DS_ID:20790 EP_NO: N/A Repair Type: No Action Needed Crossing Status: Found UCIP Comments: FIELD_STRUCT_DESC: 24-inch corrugated metal drainage pipe through the levee, 5 feet below the crown. Flap gate and concrete U-shaped headwall on the waterside (WS) end. Concrete U-shaped headwall on the landside (LS) end. [Additional Reference(s): DWR Levee Log, 1992. USACE Sacramento O&M Manual 510, April 1963, (HLM 1.10) Drawing No. 50-4-3622]. FS Date: 10/3/2013

Concrete U-shaped headwall and flapgate on WS toe.

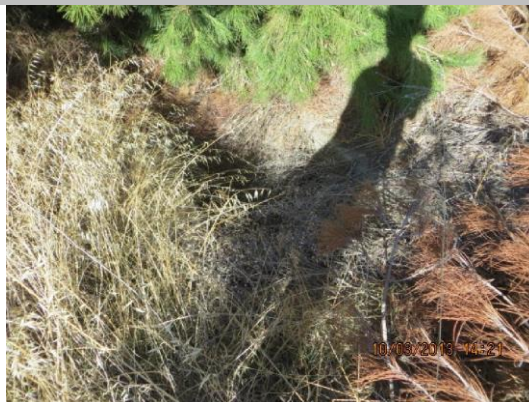
Photo 3 of 3 : UCIP_SP_2018_21788_37052.jpg

Concrete U-shaped headwall on LS toe.

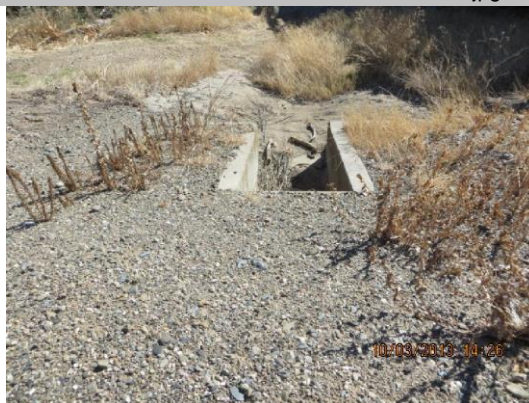
Photo 1 of 2 : UCIP_SP_2018_21786_37048.jpg

LM Start	1.11	Rating **	A/W	Issue No.	925
LM End	1.11	Issue Type +	Ma	Location *	
Category	Supplemental			GPS Latitude/Longitude	
				Start	End
Item	DWR UCIP LMA Responsibility			40.051958 °	40.051958 °
				-122.170031 °	-122.170031 °
DWR ID					
Comment Code					
Inspector Comment					
FS_ID:21786 DS_ID:20773 EP_NO: N/A Repair Type: No Action Needed Crossing Status: Found UCIP Comments: FIELD_STRUCT_DESC: 24-inch corrugated metal drainage pipe through the levee, 5.1 feet below the crown. Flap gate and concrete U-shaped headwall on the waterside (WS) end. Concrete U-shaped headwall on the landside (LS) end. [Additional Reference(s): DWR Levee Log, 1992. USACE Sacramento O&M Manual 510, April 1963, (HLM 1.12) Drawing No. 50-4-3622]. FS Date: 10/3/2013

Concrete U-shaped headwall and flapgate on WS slope.

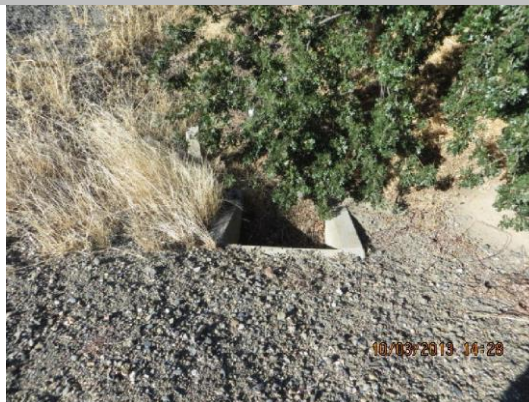
Photo 2 of 2 : UCIP_SP_2018_21786_37047.jpg

Concrete U-shaped headwall on LS toe.

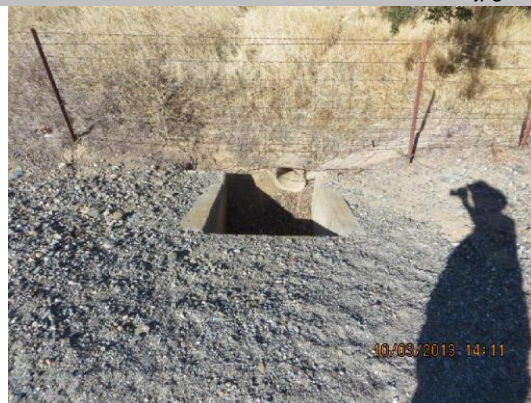
Photo 1 of 3 : UCIP_SP_2018_21778_37037.jpg

LM Start	1.30	Rating **	A/W	Issue No.	926
LM End	1.30	Issue Type +	Ma	Location *	
Category	Supplemental			GPS Latitude/Longitude	
				Start	End
Item	DWR UCIP LMA Responsibility			40.051563 °	40.051563 °
				-122.166630 °	-122.166630 °
DWR ID					
Comment Code					
Inspector Comment					
FS_ID:21778 DS_ID:20782 EP_NO: N/A Repair Type: No Action Needed Crossing Status: Found UCIP Comments: FIELD_STRUCT_DESC: 24-inch corrugated metal drainage pipe through the levee, 4.5 feet below the crown. Flap gate and concrete U-shaped headwall on the waterside (WS) end. Concrete U-shaped headwall on the landside (LS) end. [Additional Reference(s): DWR Levee Log, 1992. USACE Sacramento O&M Manual 510, April 1963, (HLM 1.30) Drawing No. 50-4-3622]. FS Date: 10/3/2013

Concrete U-shaped headwall on LS toe.

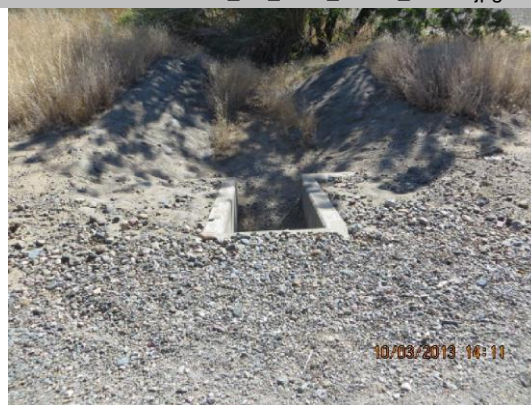
Photo 2 of 3 : UCIP_SP_2018_21778_37036.jpg

Concrete U-shaped headwall on WS toe.

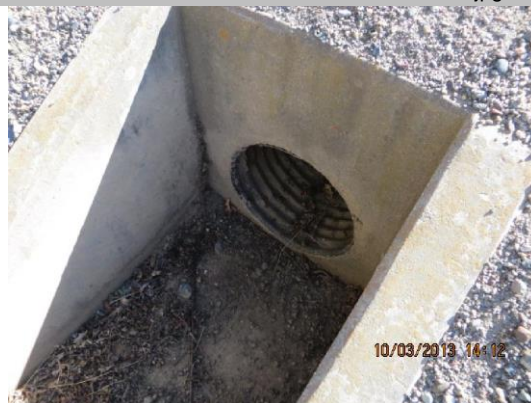
Photo 3 of 3 : UCIP_SP_2018_21778_37035.jpg

LM Start	1.30	Rating **	A/W	Issue No.	926 (cont)	
LM End	1.30	Issue Type +	Ma	Location *		
Category	Supplemental			GPS Latitude/Longitude		
				Start		End
Item	DWR UCIP LMA Responsibility			40.051563 °		40.051563 °
				-122.166630 °		-122.166630 °
DWR ID						
Comment Code						
Inspector Comment						
FS_ID:21778						
DS_ID:20782						
EP_NO: N/A						
Repair Type: No Action Needed						
Crossing Status: Found						
UCIP Comments:						
FIELD_STRUCT_DESC: 24-inch corrugated metal drainage pipe through the levee, 4.5 feet below the crown. Flap gate and concrete U-shaped headwall on the waterside (WS) end. Concrete U-shaped headwall on the landside (LS) end. [Additional Reference(s): DWR Levee Log, 1992. USACE Sacramento O&M Manual 510, April 1963, (HLM 1.30) Drawing No. 50-4-3622].						
FS Date: 10/3/2013

Concrete U-shaped headwall on LS toe.

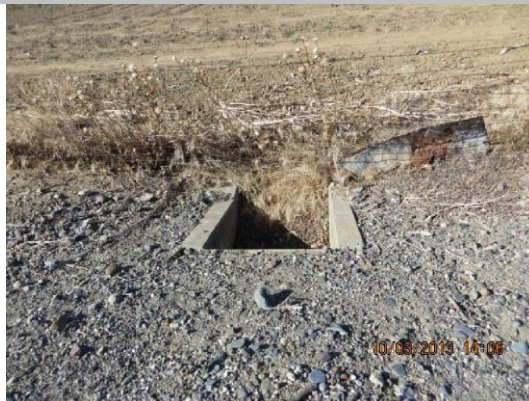
Photo 1 of 3 : UCIP_SP_2018_21776_37029.jpg

LM Start	1.56	Rating **	A/W	Issue No.	927
LM End	1.56	Issue Type +	Ma	Location *	
Category	Supplemental			GPS Latitude/Longitude	
				Start	End
Item	DWR UCIP LMA Responsibility			40.052495 °	40.052495 °
				-122.161921 °	-122.161921 °
DWR ID					
Comment Code					
Inspector Comment					
FS_ID:21776					
DS_ID:20783					
EP_NO: N/A					
Repair Type: No Action Needed					
Crossing Status: Found					
UCIP Comments:					
FIELD_STRUCT_DESC: 24-inch corrugated metal drainage pipe through the levee, 5.8 feet below the crown. Flap gate and concrete U-shaped headwall on the waterside (WS) end. Concrete U-shaped headwall on the landside (LS) end. [Additional Reference(s): DWR Levee Log, 1992. USACE Sacramento O&M Manual 510, April 1963, (HLM 1.57) Drawing No. 50-4-3622].					
FS Date: 10/3/2013

Concrete U-shaped headwall on LS toe.

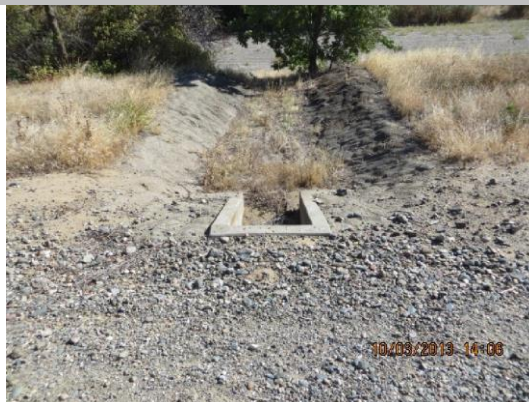
Photo 2 of 3 : UCIP_SP_2018_21776_37028.jpg

Concrete U-shaped headwall on WS toe.

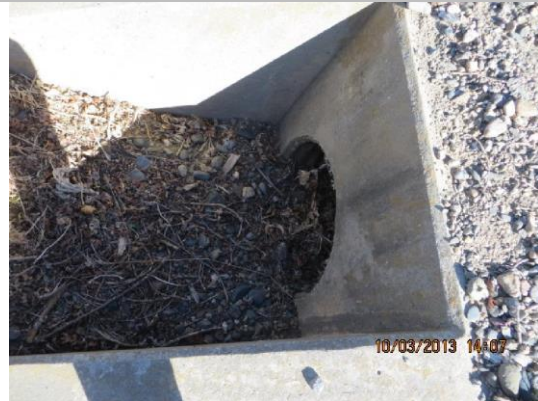
Photo 3 of 3 : UCIP_SP_2018_21776_37027.jpg

LM Start	1.56	Rating **	A/W	Issue No.	927 (cont)	
LM End	1.56	Issue Type +	Ma	Location *		
Category	Supplemental			GPS Latitude/Longitude		
				Start	End	
Item	DWR UCIP LMA Responsibility			40.052495 °	40.052495 °	
				-122.161921 °	-122.161921 °	
DWR ID						
Comment Code						
Inspector Comment						
FS_ID:21776						
DS_ID:20783						
EP_NO: N/A						
Repair Type: No Action Needed						
Crossing Status: Found						
UCIP Comments:						
FIELD_STRUCT_DESC: 24-inch corrugated metal drainage pipe through the levee, 5.8 feet below the crown. Flap gate and concrete U-shaped headwall on the waterside (WS) end. Concrete U-shaped headwall on the landside (LS) end. [Additional Reference(s): DWR Levee Log, 1992. USACE Sacramento O&M Manual 510, April 1963, (HLM 1.57) Drawing No. 50-4-3622].						
FS Date: 10/3/2013

Concrete U-shaped headwall on LS toe.

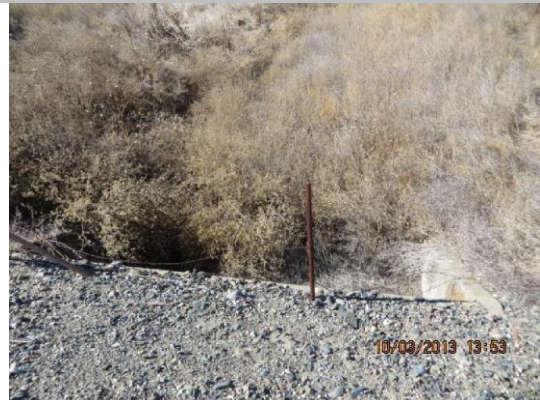
Photo 1 of 3 : UCIP_SP_2018_21769_37004.jpg

LM Start	1.69	Rating **	A/W	Issue No.	928
LM End	1.69	Issue Type +	Ma	Location *	
Category	Supplemental			GPS Latitude/Longitude	
				Start	End
Item	DWR UCIP LMA Responsibility			40.053590 °	40.053590 °
				-122.159982 °	-122.159982 °
DWR ID					
Comment Code					
Inspector Comment					
FS_ID:21769 DS_ID:20786 EP_NO: N/A Repair Type: No Action Needed Crossing Status: Found UCIP Comments: FIELD_STRUCT_DESC: 1 of 3: 36-inch corrugated metal drainage pipe through the levee, 7.3 feet below the crown. Flap gate and concrete U-shaped headwall on the waterside (WS) end. Concrete U-shaped headwall on the landside (LS) end. [Additional Reference(s): DWR Levee Log, 1992. USACE Sacramento O&M Manual 510, April 1963, (HLM 1.70) Drawing No. 50-4-3622]. FS Date: 10/3/2013

Concrete inlet on LS toe.

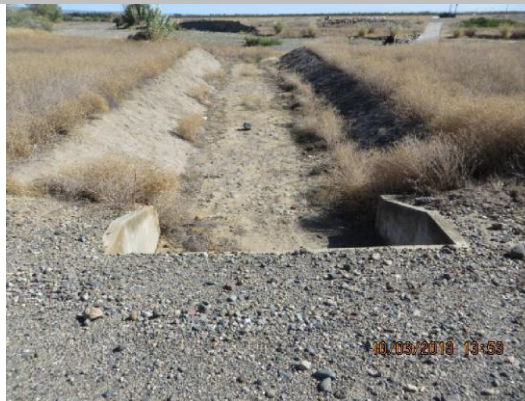
Photo 2 of 3 : UCIP_SP_2018_21769_37003.jpg

FS_ID:21769
DS_ID:20786
EP_NO: N/A
Repair Type: No Action Needed
Crossing Status: Found
UCIP Comments:
FIELD_STRUCT_DESC: 1 of 3: 36-inch corrugated metal drainage pipe through the levee, 7.3 feet below the crown. Flap gate and concrete U-shaped headwall on the waterside (WS) end. Concrete U-shaped headwall on the landside (LS) end. [Additional Reference(s): DWR Levee Log, 1992. USACE Sacramento O&M Manual 510, April 1963, (HLM 1.70) Drawing No. 50-4-3622].
FS Date: 10/3/2013

Concrete inlet on WS toe.

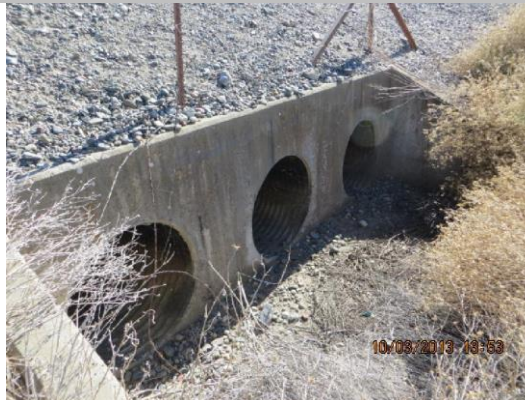
Photo 3 of 3 : UCIP_SP_2018_21769_37002.jpg

Concrete inlet on LS toe.

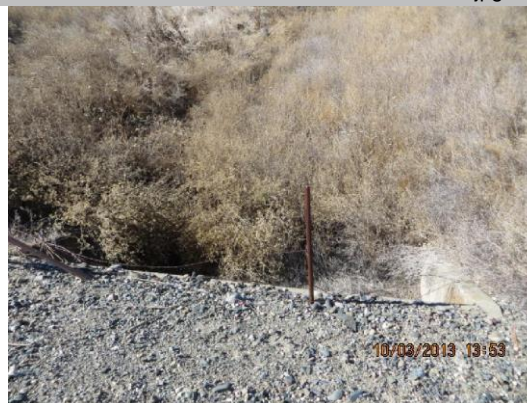
Photo 1 of 3 : UCIP_SP_2018_21768_37000.jpg

LM Start	1.69	Rating **	A/W	Issue No.	929
LM End	1.69	Issue Type +	Ma	Location *	
Category	Supplemental			GPS Latitude/Longitude	
				Start	End
Item	DWR UCIP LMA Responsibility			40.053601 °	40.053601 °
				-122.159966 °	-122.159966 °
DWR ID					
Comment Code					
Inspector Comment					
FS_ID:21768 DS_ID:20883 EP_NO: N/A Repair Type: No Action Needed Crossing Status: Found UCIP Comments: FIELD_STRUCT_DESC: 2 of 3: 36-inch corrugated metal drainage pipe through the levee, 7.3 feet below the crown. Flap gate and concrete U-shaped headwall on the waterside (WS) end. Concrete U-shaped headwall on the landside (LS) end. [Additional Reference(s): DWR Levee Log, 1992. USACE Sacramento O&M Manual 510, April 1963, (HLM 1.70) Drawing No. 50-4-3622]. FS Date: 10/3/2013

Concrete headwall on LS toe.

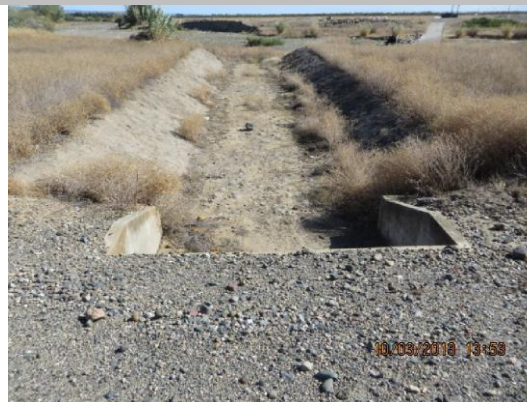
Photo 2 of 3 : UCIP_SP_2018_21768_36999.jpg

Concrete headwall on WS toe.

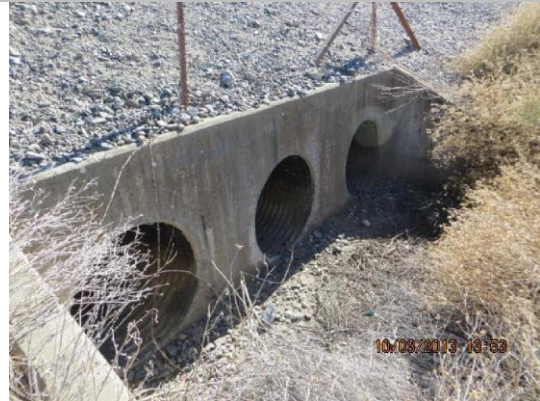
Photo 3 of 3 : UCIP_SP_2018_21768_36998.jpg

LM Start	1.69	Rating **	A/W	Issue No.	929 (cont)	
LM End	1.69	Issue Type +	Ma	Location *		
Category	Supplemental			GPS Latitude/Longitude		
				Start	End	
Item	DWR UCIP LMA Responsibility			40.053601 °	40.053601 °	
				-122.159966 °	-122.159966 °	
DWR ID						
Comment Code						
Inspector Comment						
FS_ID:21768						
DS_ID:20883						
EP_NO: N/A						
Repair Type: No Action Needed						
Crossing Status: Found						
UCIP Comments:						
FIELD_STRUCT_DESC: 2 of 3: 36-inch corrugated metal drainage pipe through the levee, 7.3 feet below the crown. Flap gate and concrete U-shaped headwall on the waterside (WS) end. Concrete U-shaped headwall on the landside (LS) end. [Additional Reference(s): DWR Levee Log, 1992. USACE Sacramento O&M Manual 510, April 1963, (HLM 1.70) Drawing No. 50-4-3622].						
FS Date: 10/3/2013

Concrete headwall on LS toe.

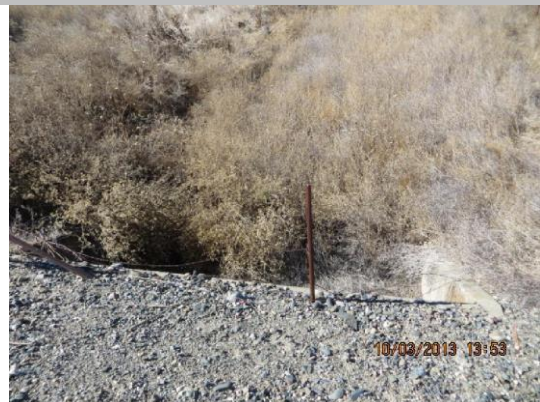
Photo 1 of 3 : UCIP_SP_2018_21767_36996.jpg

LM Start	1.69	Rating **	A/W	Issue No.	930
LM End	1.69	Issue Type +	Ma	Location *	
Category	Supplemental			GPS Latitude/Longitude	
				Start	End
Item	DWR UCIP LMA Responsibility			40.053614 °	40.053614 °
				-122.159956 °	-122.159956 °
DWR ID					
Comment Code					
Inspector Comment					
FS_ID:21767 DS_ID:20884 EP_NO: N/A Repair Type: No Action Needed Crossing Status: Found UCIP Comments: FIELD_STRUCT_DESC: 3 of 3: 36-inch corrugated metal drainage pipe through the levee, 7.3 feet below the crown. Flap gate and concrete U-shaped headwall on the waterside (WS) end. Concrete U-shaped headwall on the landside (LS) end. [Additional Reference(s): DWR Levee Log, 1992. USACE Sacramento O&M Manual 510, April 1963, (HLM 1.70) Drawing No. 50-4-3622]. FS Date: 10/3/2013

Concrete headwall on LS slope.

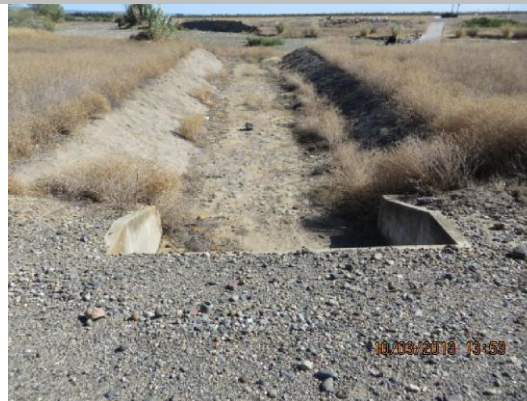
Photo 2 of 3 : UCIP_SP_2018_21767_36995.jpg

Concrete headwall on WS toe.

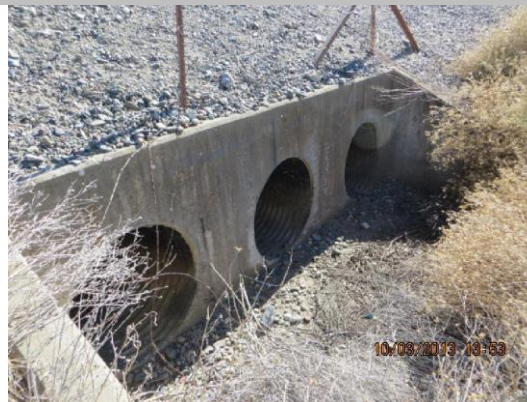
Photo 3 of 3 : UCIP_SP_2018_21767_36994.jpg

Concrete headwall on LS toe.

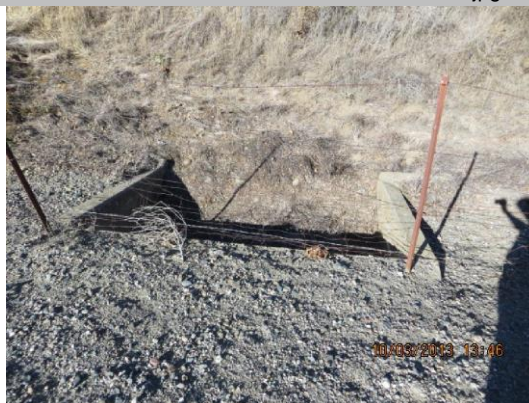
Photo 1 of 3 : UCIP_SP_2018_21766_36992.jpg

LM Start	1.99	Rating **	A/W	Issue No.	931
LM End	1.99	Issue Type +	Ma	Location *	
Category	Supplemental			GPS Latitude/Longitude	
				Start	End
Item	DWR UCIP LMA Responsibility			40.052731 °	40.052731 °
				-122.154695 °	-122.154695 °
DWR ID					
Comment Code					
Inspector Comment					
FS_ID:21766					
DS_ID:20787					
EP_NO: N/A					
Repair Type: No Action Needed					
Crossing Status: Found					
UCIP Comments:					
FIELD_STRUCT_DESC: 1 of 2: 36-inch corrugated metal drainage pipe through the levee, 7.6 feet below the crown. Flap gate and concrete U-shaped headwall on the waterside (WS) end. Concrete U-shaped headwall on the landside (LS) end. [Additional Reference(s): DWR Levee Log, 1992. USACE Sacramento O&M Manual 510, April 1963, (HLM 2.01) Drawing No. 50-4-3622].					
FS Date: 10/3/2013

Concrete headwall on LS toe.

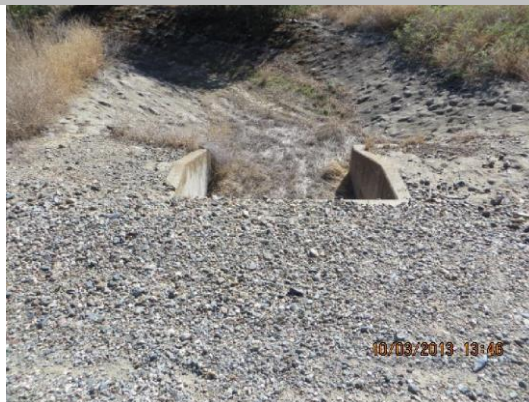
Photo 2 of 3 : UCIP_SP_2018_21766_36991.jpg

Concrete headwall on WS toe.

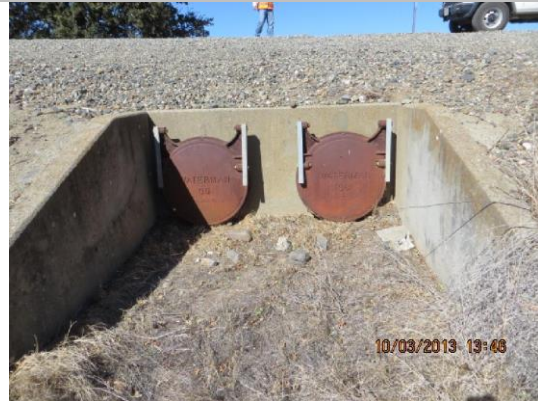
Photo 3 of 3 : UCIP_SP_2018_21766_36990.jpg

Flapgate on WS toe.

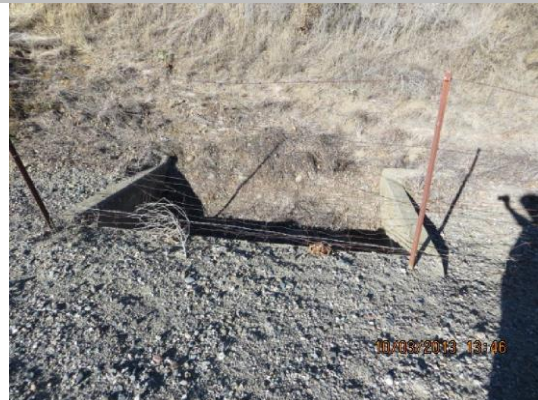
Photo 1 of 3 : UCIP_SP_2018_22828_38978.jpg

LM Start	1.99	Rating **	A/W	Issue No.	932
LM End	1.99	Issue Type +	Ma	Location *	
Category	Supplemental			GPS Latitude/Longitude	
				Start	End
Item	DWR UCIP LMA Responsibility			40.052729 °	40.052729 °
				-122.154673 °	-122.154673 °
DWR ID					
Comment Code					
Inspector Comment					
FS_ID:22828 DS_ID:20885 EP_NO: N/A Repair Type: No Action Needed Crossing Status: Found UCIP Comments: FIELD_STRUCT_DESC: 2 of 2: 36-inch corrugated metal drainage pipe through the levee, 7.6 feet below the crown. Flap gate and concrete U-shaped headwall on the waterside (WS) end. Concrete U-shaped headwall on the landside (LS) end. [Additional Reference(s): DWR Levee Log, 1992. USACE Sacramento O&M Manual 510, April 1963, (HLM 2.01) Drawing No. 50-4-3622]. FS Date: 10/3/2013

Concrete headwall on LS toe.

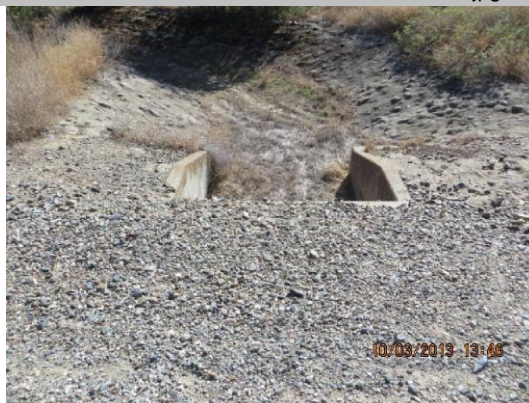
Photo 2 of 3 : UCIP_SP_2018_22828_38977.jpg

Concrete headwall and concrete channel on WS toe.

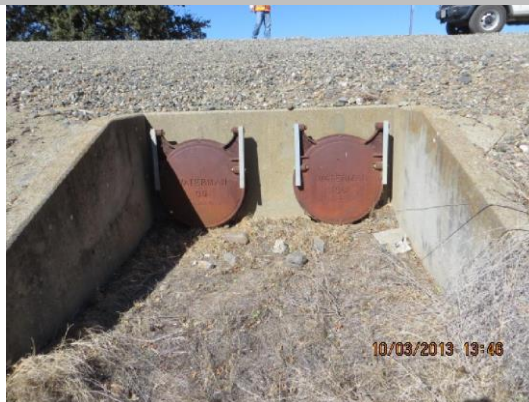
Photo 3 of 3 : UCIP_SP_2018_22828_38980.jpg

Flapgate on headwall at WS toe.

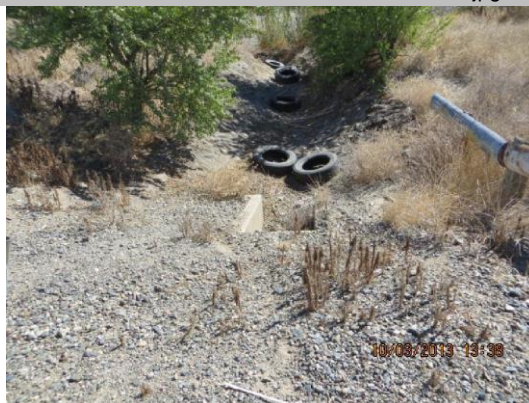
Photo 1 of 3 : UCIP_SP_2018_21763_36982.jpg

LM Start	2.21	Rating **	A/W	Issue No.	933
LM End	2.21	Issue Type +	Ma	Location *	
Category	Supplemental			GPS Latitude/Longitude	
				Start	End
Item	DWR UCIP LMA Responsibility			40.051985 °	40.051985 °
				-122.150737 °	-122.150737 °
DWR ID					
Comment Code					
Inspector Comment					
FS_ID:21763 DS_ID:20788 EP_NO: N/A Repair Type: No Action Needed Crossing Status: Found UCIP Comments: FIELD_STRUCT_DESC: 24-inch corrugated metal drainage pipe through the levee, 5.9 feet below the crown. Flap gate and concrete U-shaped headwall on the waterside (WS) end. Concrete U-shaped headwall on the landside (LS) end. [Additional Reference(s): DWR Levee Log, 1992. USACE Sacramento O&M Manual 510, April 1963, (HLM 2.24) Drawing No. 50-4-3622]. FS Date: 10/3/2013

Concrete U-shaped headwall on WS slope.

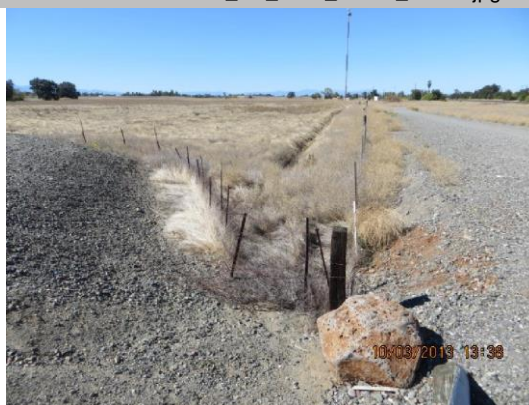
Photo 2 of 3 : UCIP_SP_2018_21763_36981.jpg

Inlet off LS toe in channel.

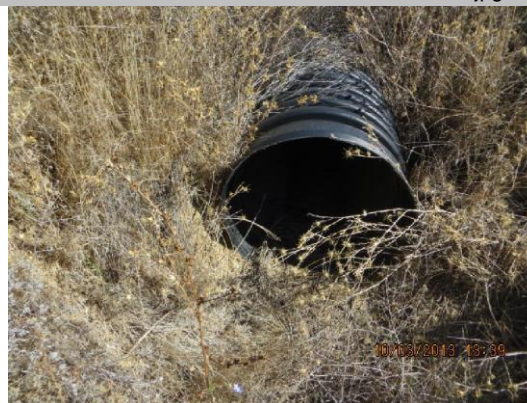
Photo 3 of 3 : UCIP_SP_2018_21763_36980.jpg

HDPE pipe inlet on LS toe.
